Ashley Giegel – ME 345- Extra Part of “Stimulus Package”

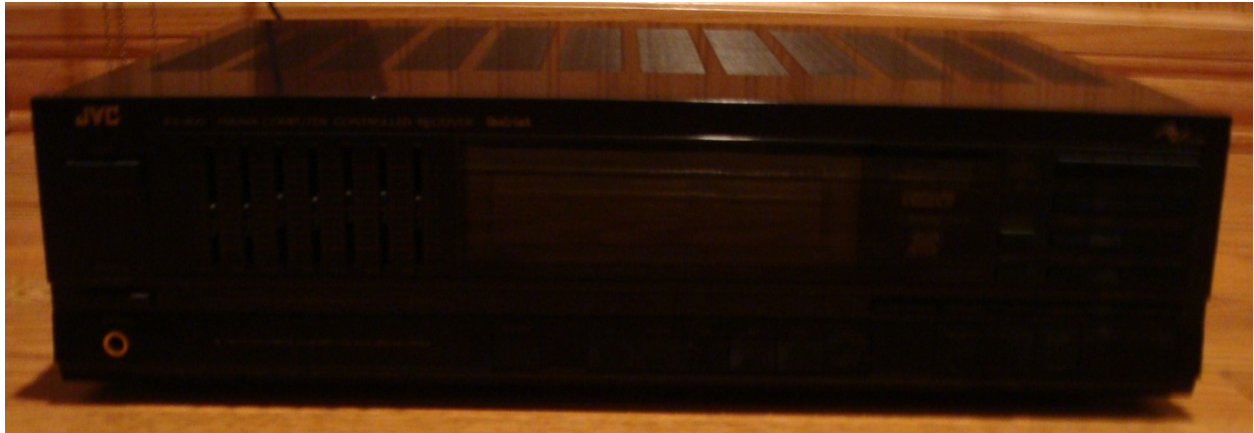
Receiver with lights out

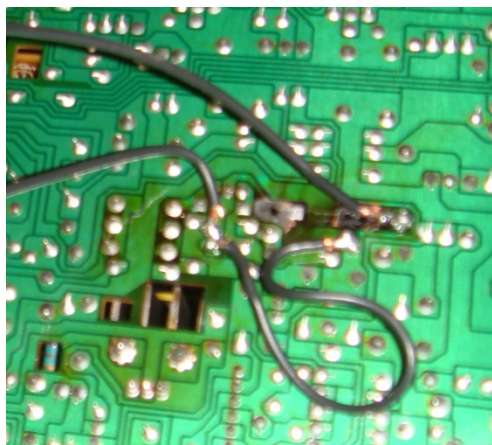
Once we got access to the circuit board we found the piece that was making the lights go out. The obvious trigger was the discoloration around a resistor on the printed circuit board. We found that as the circuit board heated up the resistor would lose contact therefore no current was getting to the lights to light up the screen. This noncontact created damage to the circuit board and to fix it we needed to attach our own resistor. We traced back on the circuit board to a point where we could add the resistor in place of the damaged one. We then used connecting wires and soldered this new resistor into place on the circuit board.
