The Pennsylvania State University

AN ANALYSIS OF COMPLEX VEHICLE RELIABILITY: A SYSTEMATIC FAILURE RATE APPROACH

A Thesis in Mechanical Engineering by Joseph M. Yutko

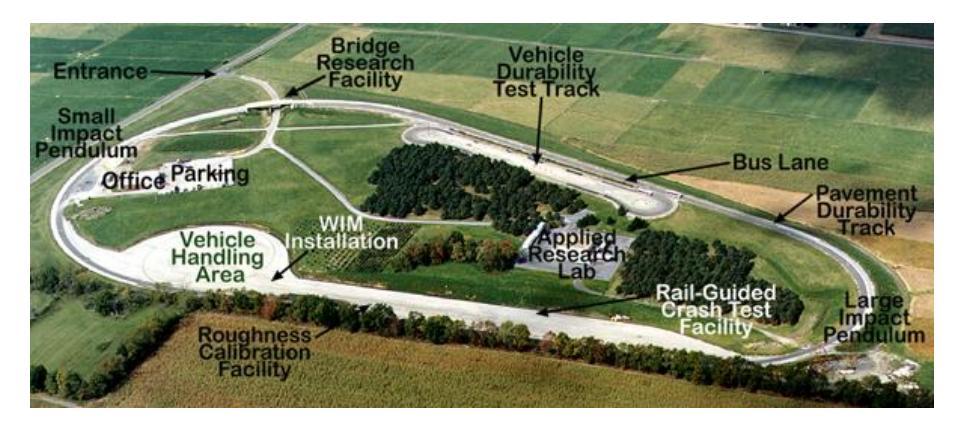
Figure 1.2. The PTI Test Track [2].

The PTI test track (Figure 1.2), built in 1970, is a 5042 ft long oval-shaped track that is used for a variety of research at Penn State [2]. Particularly, the test track is the primary locale for durability testing for the transit bus testing program.

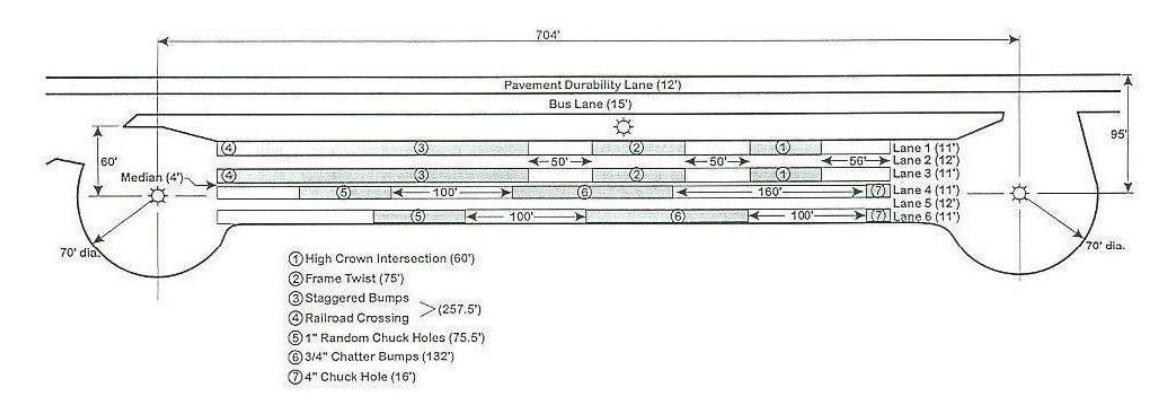
Figure 1.3. The Durability Course at the PTI Test Track [2].

The track has a 1,665 ft long vehicle durability course (Figure 1.3) that contains a variety of pavement discontinuities that simulate in-transit use of buses at an accelerated rate [2].

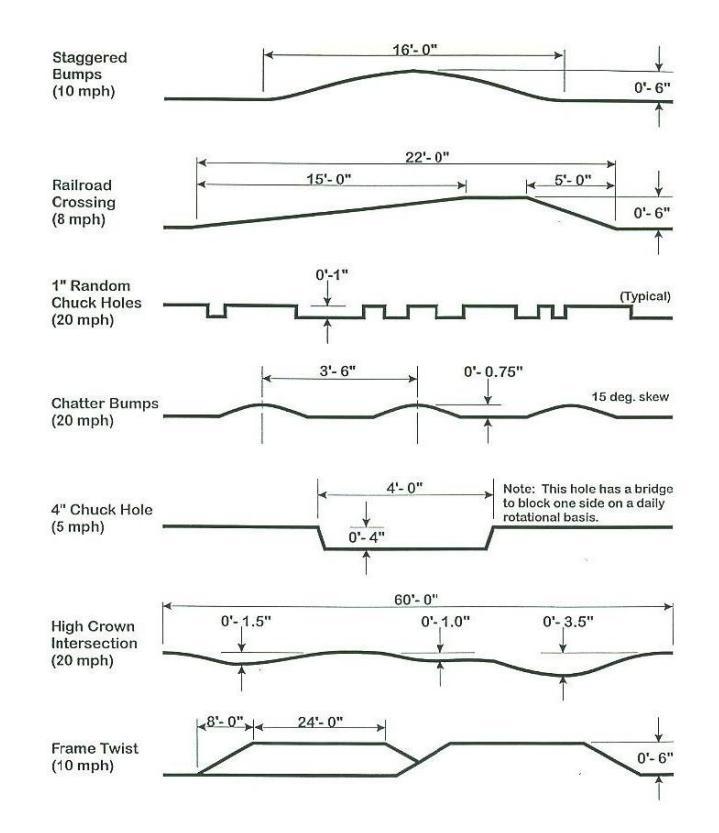
Figure 1.4. The Durability Course Profile [2].

The durability track contains seven distinct events (Figure 1.4) that the buses experience during in-transit use:

• Staggered bumps

- Railroad crossing
- 1" Random chuck holes
- Chatter bumps
- 4" Chuck holes
- High crown intersection
- Frame twist

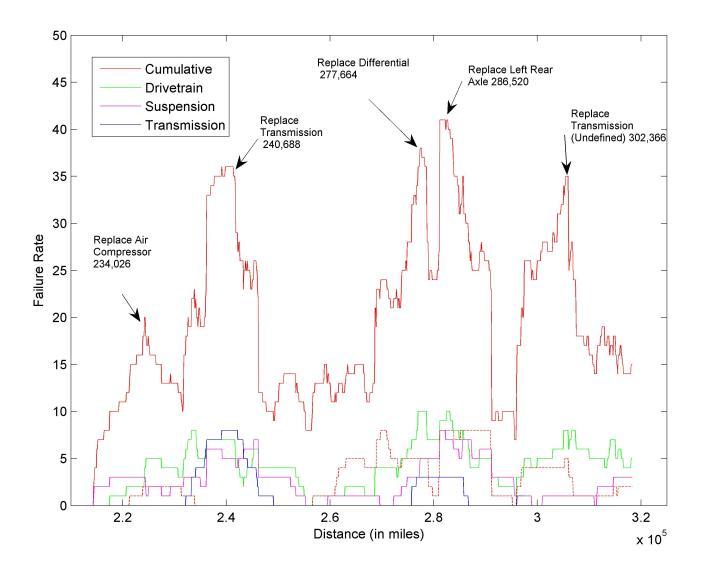
Figure 1.5. A Sample Failure Rate Subsystem Plot.

Throughout the course of the study, a large sample of data was collected from numerous agencies throughout the continental United States. Various techniques (described later) were introduced in an effort to determine correlation between the tested and in-service buses. One particular technique plotted the cumulative rate of failure versus mileage of each bus (Figure 1.5). Interestingly, the trend of the failure rate had multiple cycles consisting of an increase, peak, and decrease. Furthermore, many of the peaks coincided with the the replacement of major components. The data was further analyzed to determine if this phenomena was purely coincidence, or if there was substance in this relationship. Thus, the crux of this thesis is the a study aimed at understanding the relationship between the peaks in failure rate plots and the corresponding replacement of major system components.

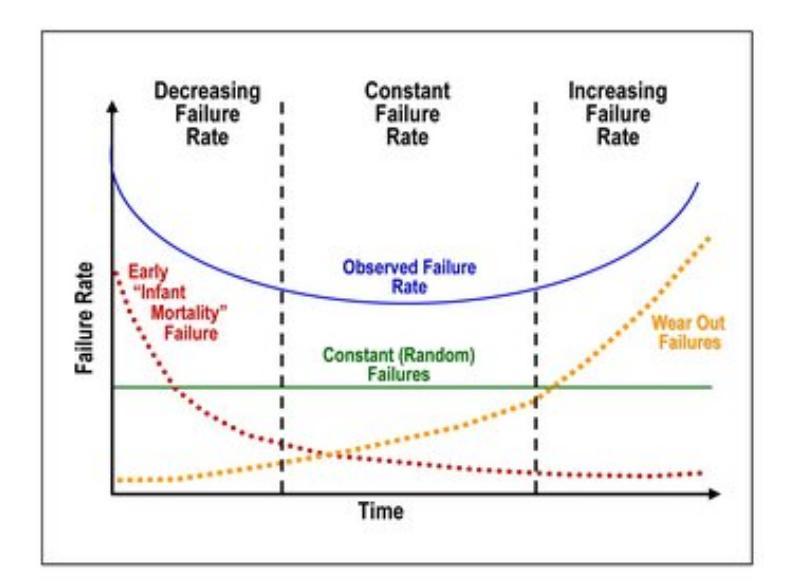
Figure 2.1. The bathtub curve [3].

For non-repairable systems, if the failure rate, h(t), is plotted versus time, it generally exhibits a bathtub shape, and thus is referred to as the *bathtub curve* (Figure 2.1). The bathtub curve can be broken into three distinct periods. The first period is known as the *Infant Mortality* or *Burn-In* period [14]. This period represents the beginning of a product's life cycle, where the failure rate starts off very high, but also decreases rapidly. The next period, characterized by a somewhat constant failure rate where mostly random failures occur, is known as the *Useful Life* of the product [14]. A product spends most of its life here. The final period, characterized by an increasing failure rate, is called *Wear-Out* [14]. It is during this period that a component or system would be replaced because it has outlived its useful life.

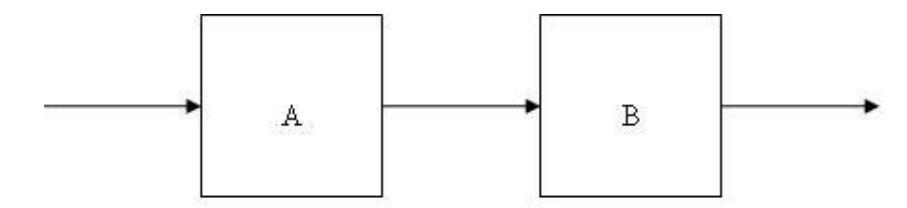
Figure 2.2. A Series Reliability Block Diagram [4].

A common tool used in analyzing system reliability is called the *Reliability Block Diagram*. The reliability block diagram is a somewhat physical approach to analyzing the system in that the way the diagram is connected shows the interdependence of the actual system. For example, a dump truck with two hydraulic cylinders lifting its dump box could be represented as two mechanical systems in parallel. If one of the cylinders fails, is still possible that the dump box could be lifted if the system was designed to do so. Conversely, if a section of the drive shaft on an automobile fails, it is certain that the auto will not move because there is no way to transmit mechanical energy to the wheels. This drive shaft example represents a series system as shown in (Figure 2.2).

In the reliability block diagram, each block represents the reliability of a component and its functional location in the system. The series block diagram (Figure 2.2) represents a system whose functional success is dependent on the the functional success of each previous component in the system. If any component of the series system fails, the entire system would fail. The reliability of Figure 2.2 is the probability that all blocks preform as expected during their predetermined

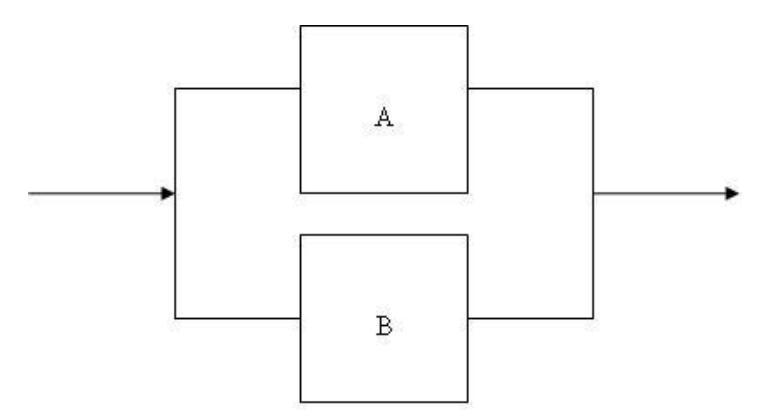
Figure 2.3. A Parallel Reliability Block Diagram [4].

The Space Shuttle main avionic computer system is a great example of a system that was intentionally built in the parallel arrangement [19]. The main avionics system was designed to be quadruple redundant, meaning any of four identical computer systems could communicate with the avionics system and preform critical flight operations [19].

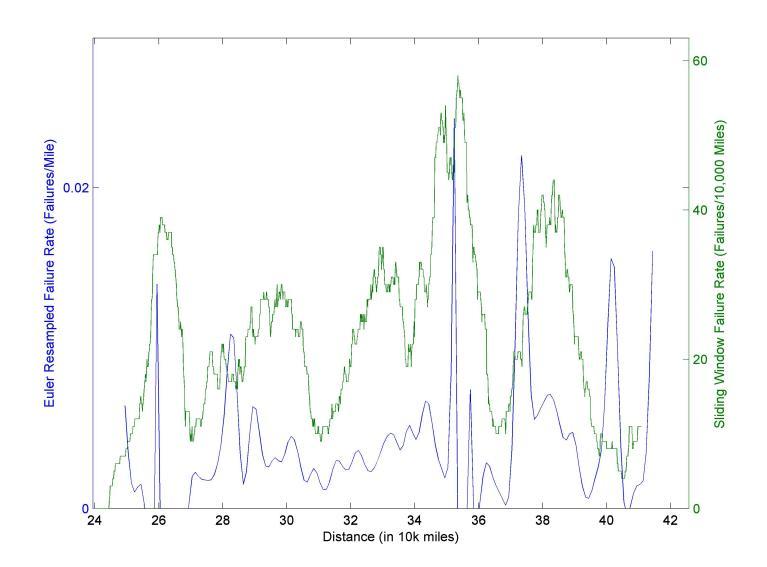
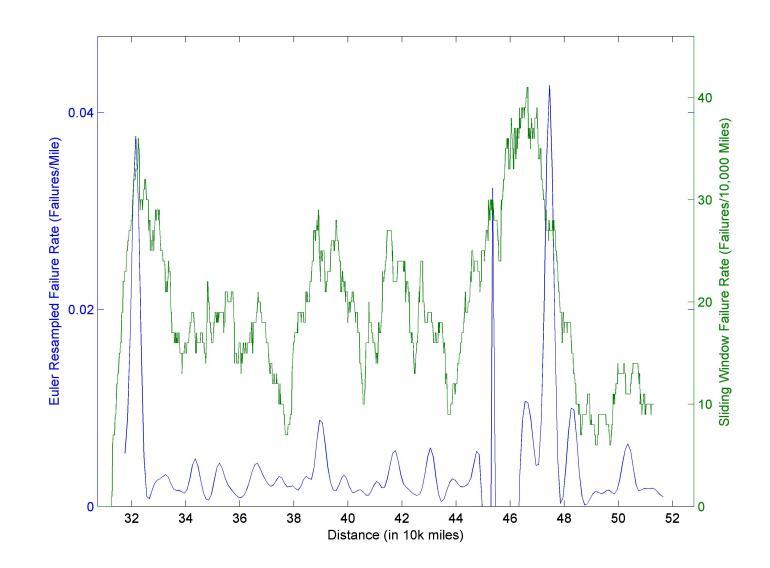
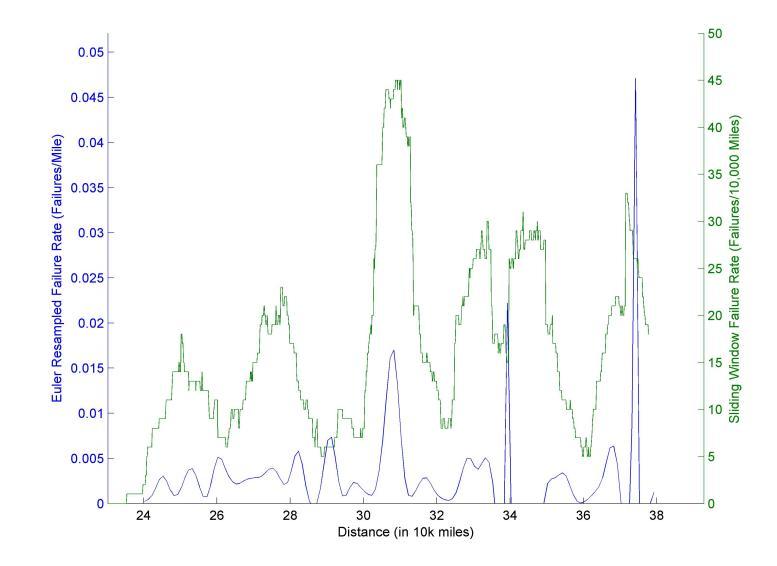
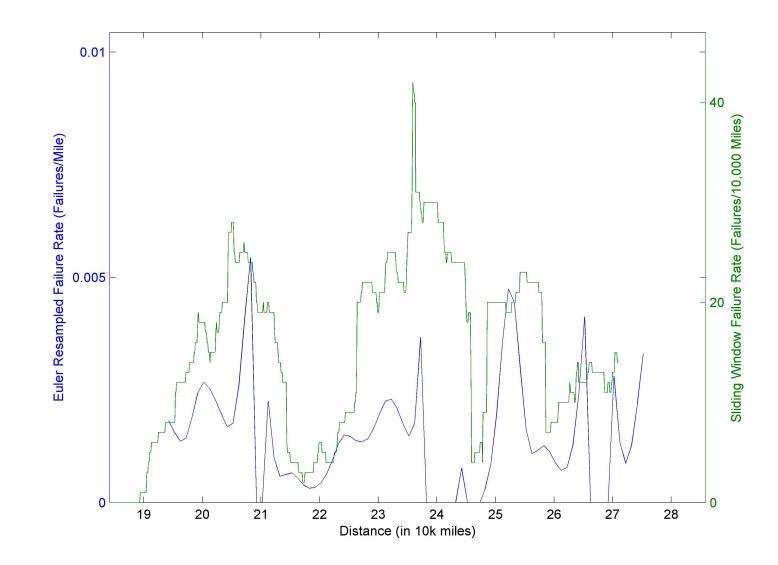
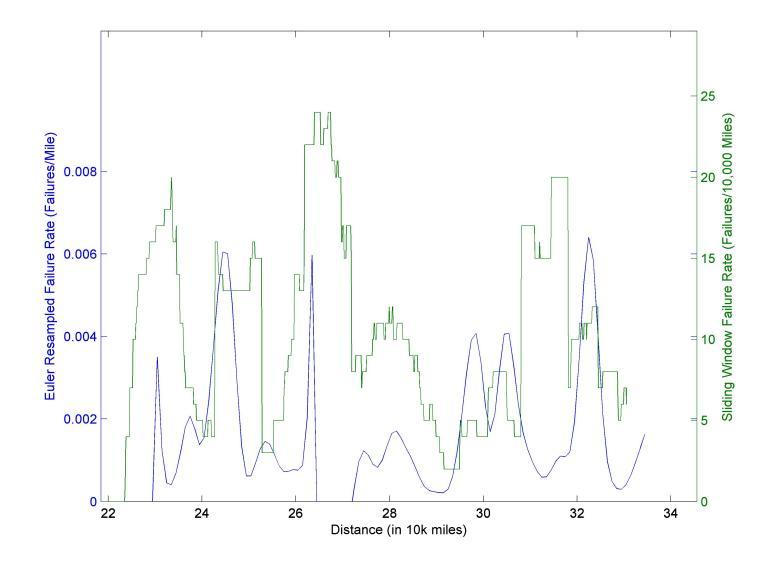
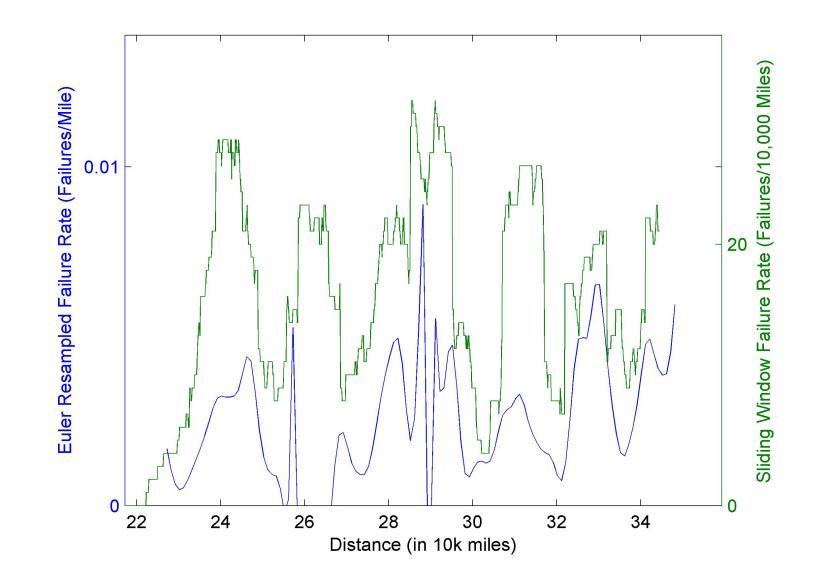
Plotting the filtered numerical derivative and sliding window derivative on the same plot gave insight into the validity of the peaks generated by the sliding window approach. The resulting plots are presented as Figures 6.15 through 6.26.

The trends exhibited by the filtered Euler numerical derivatives match well with the trends in sliding window derivatives. The peaks produced by the sliding window method also match with peaks in the Euler derivative. Thus, two independent methods of calculating failure rate produce the same results, meaning the sliding window method is an appropriate method for calculating failure rate, and the peaks generated by it are not erroneous. The peaks are indeed characteristics of the failure rate, many of which correspond with major component replacements.

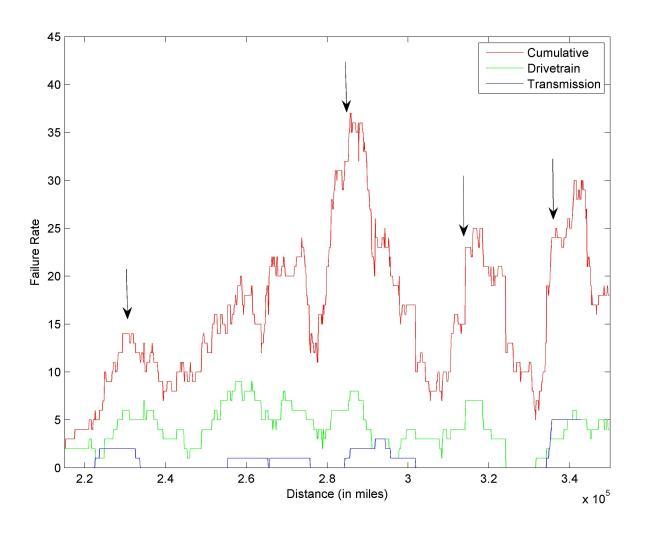
Figure 6.28. Pittsburgh 5001 Subsystem Failure Rates.

Figure 6.28 illustrates the subsystem level analog to Figure 6.7. The failure rates of systems directly associated with peaks in the cumulative failure rate are plotted on the same graph. The generator replacement at mile 228,594 that corresponds with a peak in the cumulative failure also showed up as a peak in the drivetrain subsystem. Generator failures are categorized with drivetrain failures because of their close association with the engine. The transmission replacement at 283,816 miles corresponds to a rise in both drivetrain and transmission failure rates. The engine replacement at 313,566 miles is also characterized by a rise in the drivetrain failure rate around this particular mileage. Finally, the transmission repair at 339,122 miles is characterized by an increase in both drivetrain and transmission subsystem failure rates.

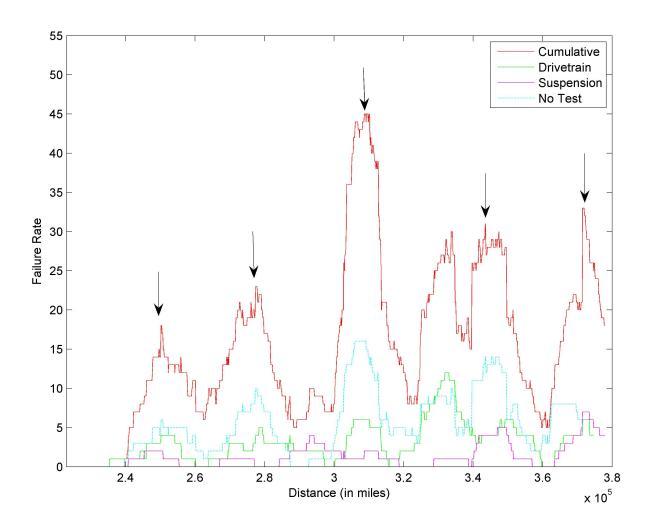
Figure 6.29. Pittsburgh 5003 Subsystem Failure Rates.

Figure 6.29 showed the failure rates corresponding to Pittsburgh bus 5003. The suspension failure at 250,272 miles is not matched very strongly by the suspension failure rate. However the drivetrain rate does rise along with suspension, and peaks at about the same time as the suspension replacement. At 281,512, the engine/turbo replacement is matched exactly with a very distinct peak in drivetrain failure rate at the same mileage. The generator and engine component replacements at 308,200 is also characterized by a rise in drivetrain failure rate. The increase and peak in drivetrain failure rate corresponds with the water pump replacement at 347,398 miles.

The items not tested at PTI were plotted here due to the large spike around 310,000 miles. The items not tested contributed significantly to the large magnitude in failure rate at this mileage.

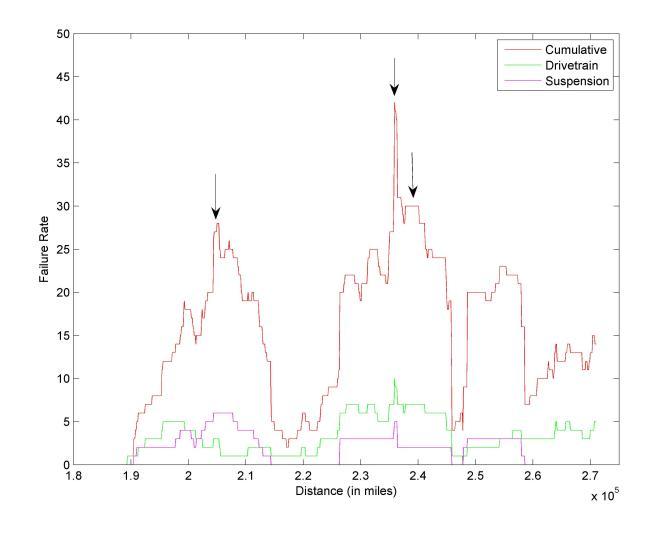
Figure 6.30. Pittsburgh 5086 Subsystem Failure Rates.

Figure 6.30 highlights an increase and peak in the suspension failure rate corresponding to a replacement of the shocks. The differential replacement at 237,316 miles was characterized with a very evident spike in both drivetrain and suspension failure rate, highlighting both their relationship with the differential, but also the interdependence vehicle subsystems have on each other. Interestingly, the engine replacement did not induce an increase in the drivetrain failure rate. The rate did, however, remain elevated until the engine was replaced.

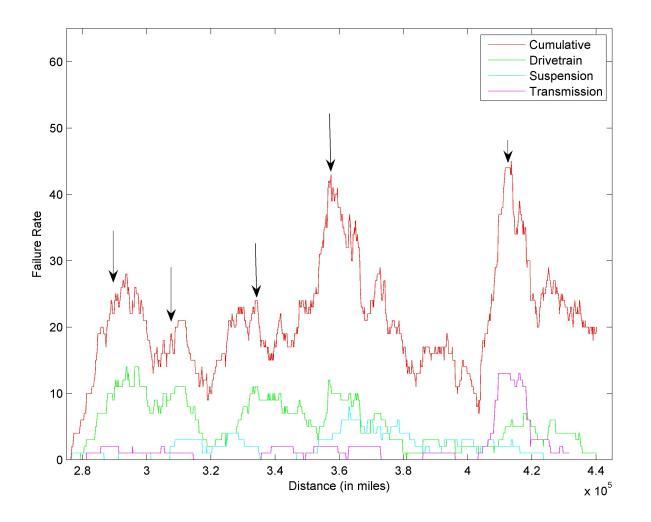
Figure 6.32. Long Beach 9410 Subsystem Failure Rates.

Figure 6.32 depicts drivetrain, suspension, and transmission subsystem failure rates, and their

relation to the cumulative failure rate. The peak in cumulative failure rate around 292,000 miles due to engine issues shows up clearly in the drivetrain failure rate. However, the transmission issues experienced at 309,350 are not depicted well by the transmission failure rate. The bus did not start at 337,097 miles, which was a culmination of increasing drivetrain failure rates leading up to that mileage. Both the cumulative and drivetrain failure rates peak at the same time and drop off significantly after the engine tune-up at 361,516 miles. The last peak in the cumulative failure rate occurrs at approximately 420,000 miles. The data shows no major component replacements near this mileage. However, the transmission failure rate was clearly a contributing factor to this peak in the cumulative rate. Upon further investigation, the transmission experienced numerous issues around this time, including not going into gear, not shifting once in gear, and not moving the bus when in gear. The agency never provided information saying the transmission or any critical drive-line components were replaced, but one can surmise that some major repair may have had taken place, and yet was not reported.

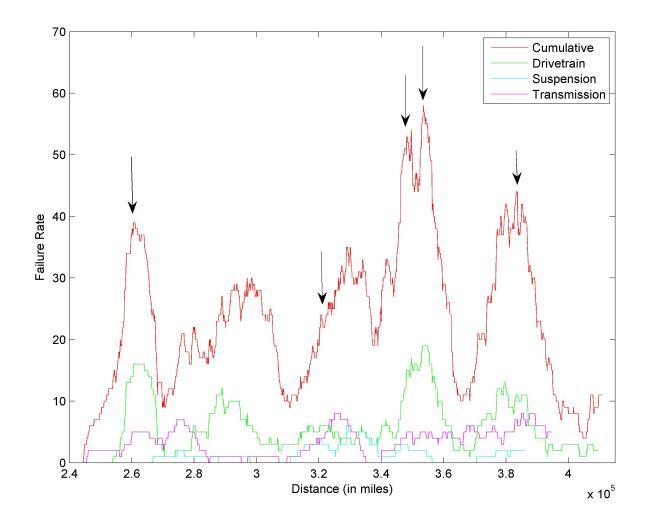
Figure 6.33. Long Beach 9414 Subsystem Failure Rates.

Figure 6.33 shows an increase in drivetrain failure rate corresponding with a generator replacement at 261,718 miles. There is also an increase in the suspension system failure rate near 333,658 miles, when the front and rear leveling valves were replaced. The drivetrain and transmission failure rates were elevated during the issues these subsystems experienced around 350,000 miles. Finally, after an overhaul at 382,026, the engine and cumulative failure rates decreased substantially.

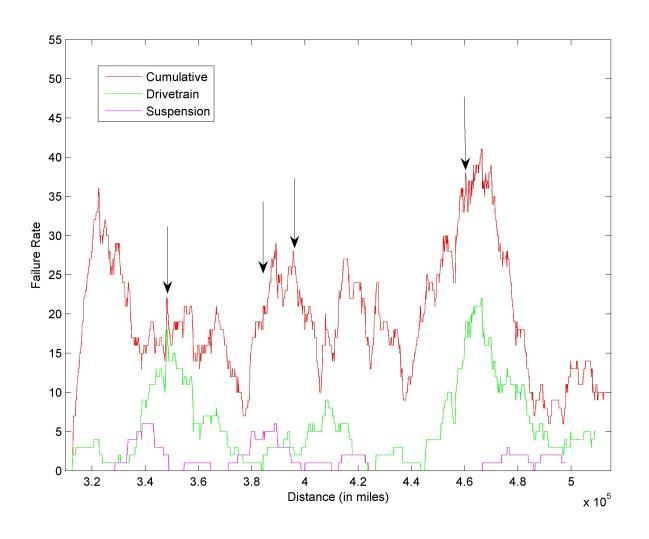
Figure 6.34. Long Beach 9419 Subsystem Failure Rates.

Figure 6.34 illustrates an increased transmission failure rate corresponding with a transmission replacement around 385,000 miles. The rebuild of the differential at 393,328, however, was not represented by an increase in drivetrain or transmission failure rate. This would be indicative of a one-time differential failure that required the component be rebuilt, or of scheduled preventative maintenance on the drive-line. The no start issues near 465,158 miles are also characterized by an increased drive-train failure rate, which decreased after the issue was resolved.

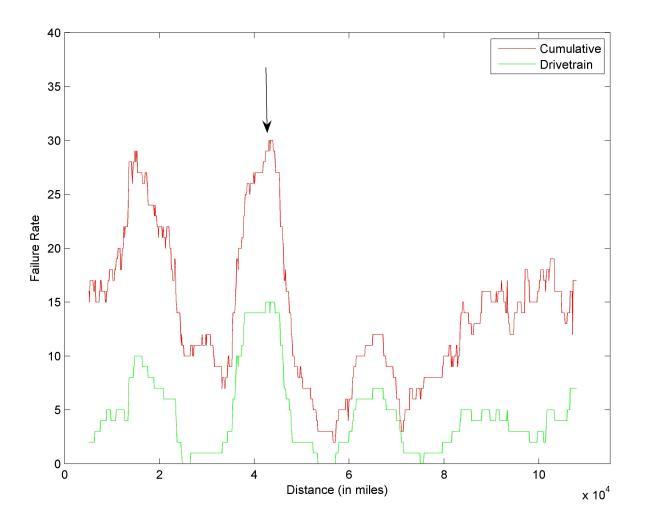
Figure 6.35. Dover 613 Subsystem Failure Rates.

Figure 6.35 clearly exhibited an increased drivetrain failure rate corresponding to an engine replacement at 42,260 miles. The rate rises, peaks, and falls in direct correlation with this occurrence.

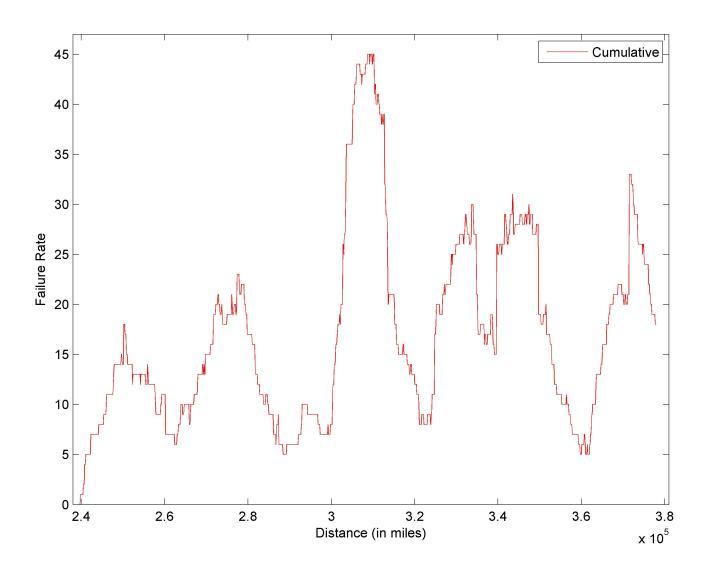
Figure 7.1. Pittsburgh Bus 5003 - Failure Rate.

Some of the failure rate plots generated for this thesis exhibit what appears to be periodicity between the peaks. Consider Figure 7.1:

The peaks in the failure rate for this bus seem to occur approximately every 3,000 miles. This could be due to many repairs being delayed until the next scheduled maintenance downtime. Thus, this future work would investigate if maintenance scheduling causes periodicity in the failure rate. By plotting all work performed on the bus, the researcher could determine if the frequency of preventative maintenance relates to the frequency of nonscheduled maintenance instances.
